Weekly Construction Report

Hatchery Creek Design/Build Project

Time Period:	August 10 - 15, 2015	Project No:	1305
Rain Days/Weather Conditions:	Rained ~0.75" on Monday (Rowena gauge) and were not able to work Monday and Tuesday because the site was too wet. We worked Wednesday through Saturday. Rained ~0.1" on Friday but did not prevent work.		
Personnel on-site:	<i>EcoGro/Ridgewater:</i> Tom Cutter, Eric Dawalt, Brad Redmon, Sherri Arthur Trucking-John Arthur.		
Equipment on-site:	Komatsu PC 360 excavator w/ hyd. thumb, Komatsu PC 450 excavator, Komatsu PC 220 long arm excavator (mobilized Tuesday), Terex TA27 articulated off-road dump truck (mobilized Thursday).		
Material deliveries to project site:	<ul style="list-style-type: none"> ▪ Two 15' wide rolls of non-woven geotextile. ▪ ~25 tons of spawning gravel. 		
Work performed the past week:	<ul style="list-style-type: none"> • Site #3/Step Pool Reach ~Sta. 156+25 to 158+50: <ul style="list-style-type: none"> ○ Excavated soil that had washed into channel down to design excavation grade. It required up to nine feet of excavation. ○ Built floodplain berm at head of step pools with excavated soil. ○ Installed non-woven geotextile

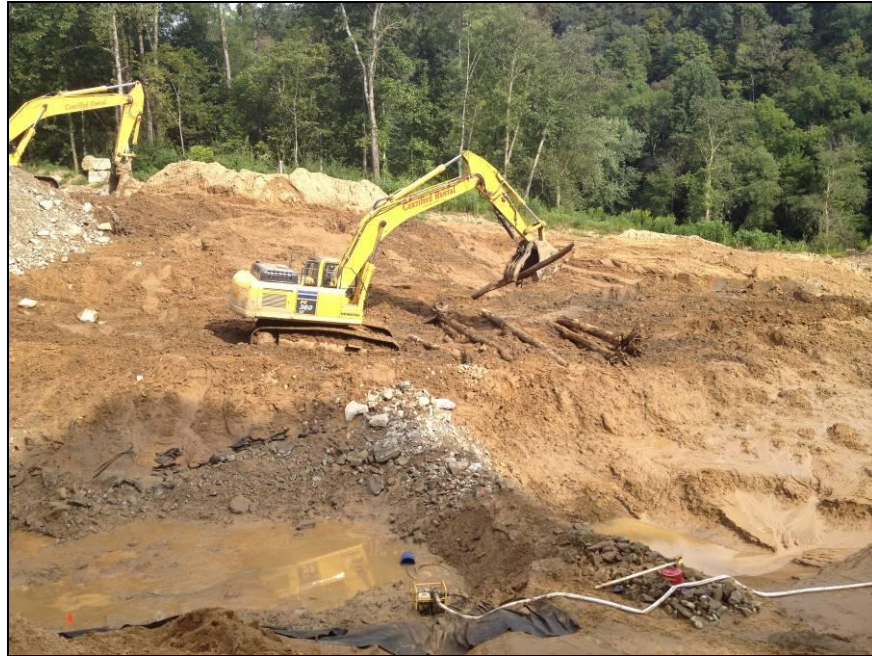
Installing logs along top of bank at Site #3/Step Pool reach in order for the long arm excavator to have a stable platform from which to excavate washed in soil. (Picture taken at ~ Sta. 158+00 looking at left descending bank).

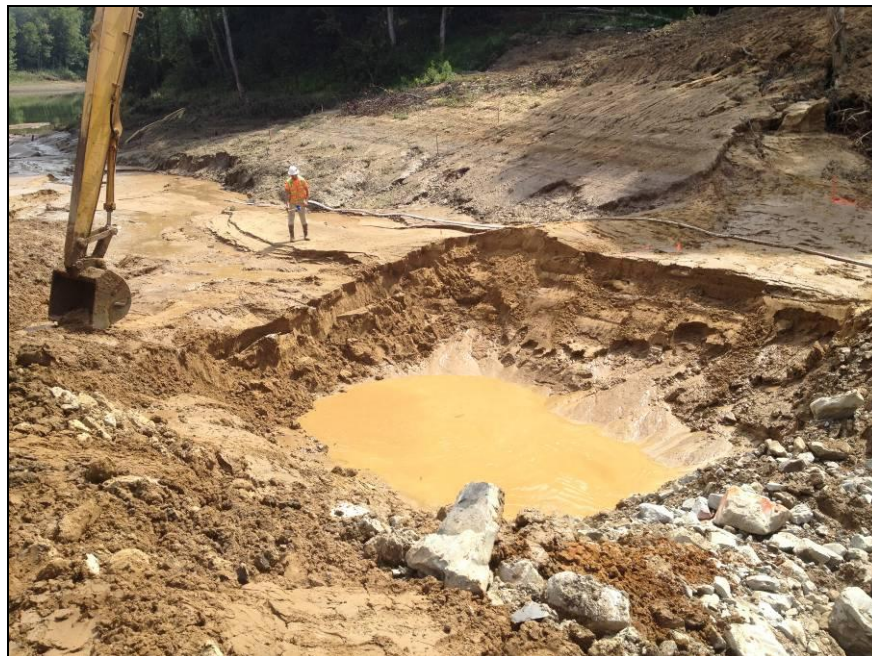
Excavating ~ 9 foot depth of washed in soil with long arm excavator on Site #3 at ~Sta. 158+00. (Picture taken looking downstream towards Cumberland River).

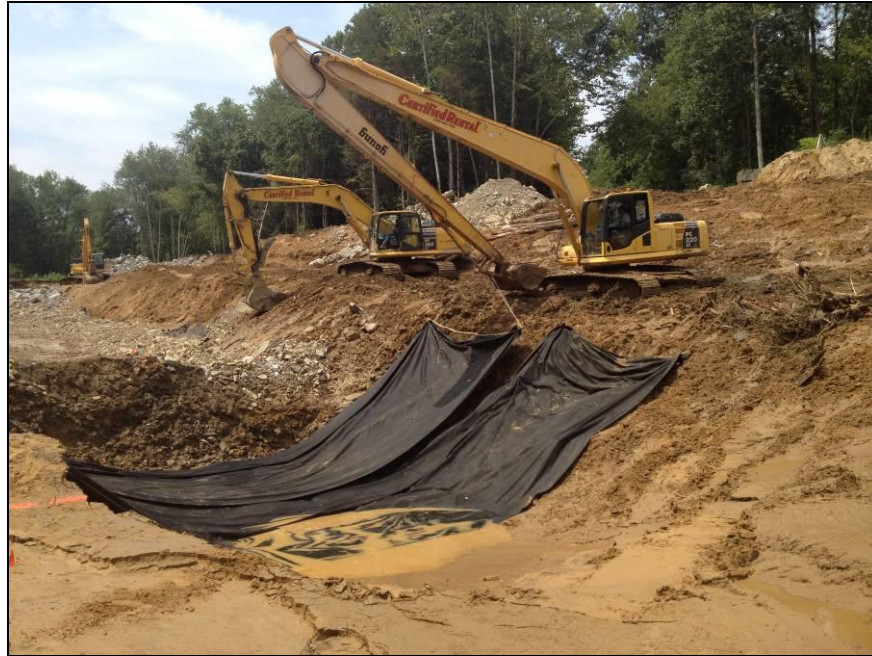
Installing geotextile fabric at ~Sta. 158+00. (Picture taken looking upstream).

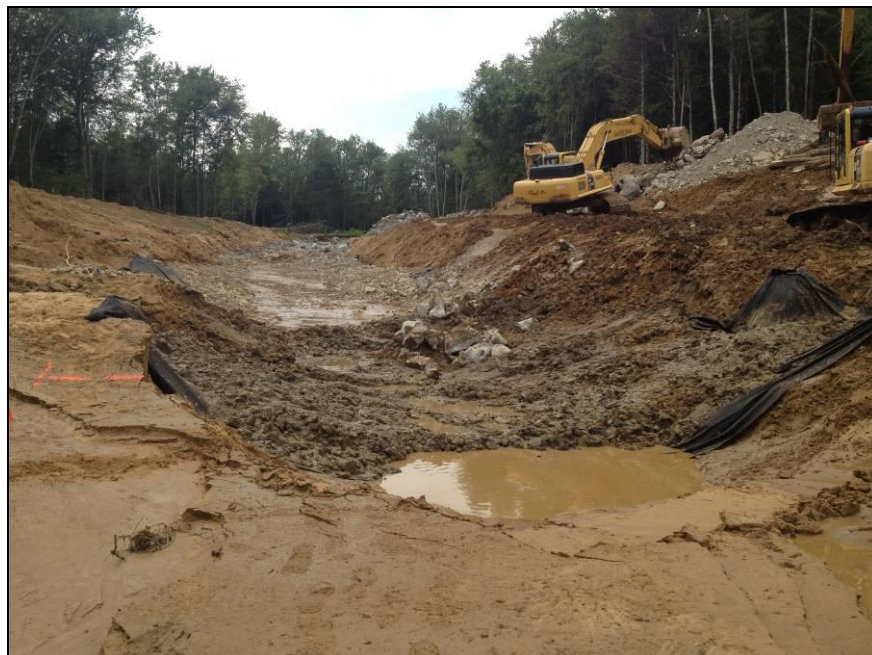
Installing ~12" layer of shot rock/class II channel lining over geotextile. (Picture taken from ~Sta. 158+50 looking upstream).

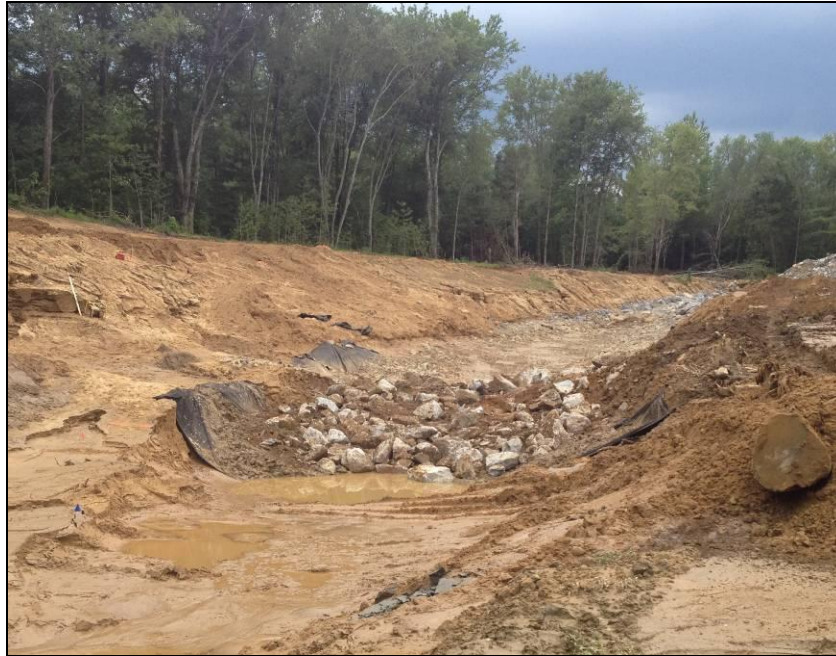
Four-foot layer of 24" diameter boulder installed over shot rock and geotextile. (Picture taken from ~Sta. 159+50 looking upstream).
